REPORT ON INSTALLATION OF GENERATION (Gen) 3 WIMEA-ICT AUTOMATIC WEATHER STATIONS IN UGANDA

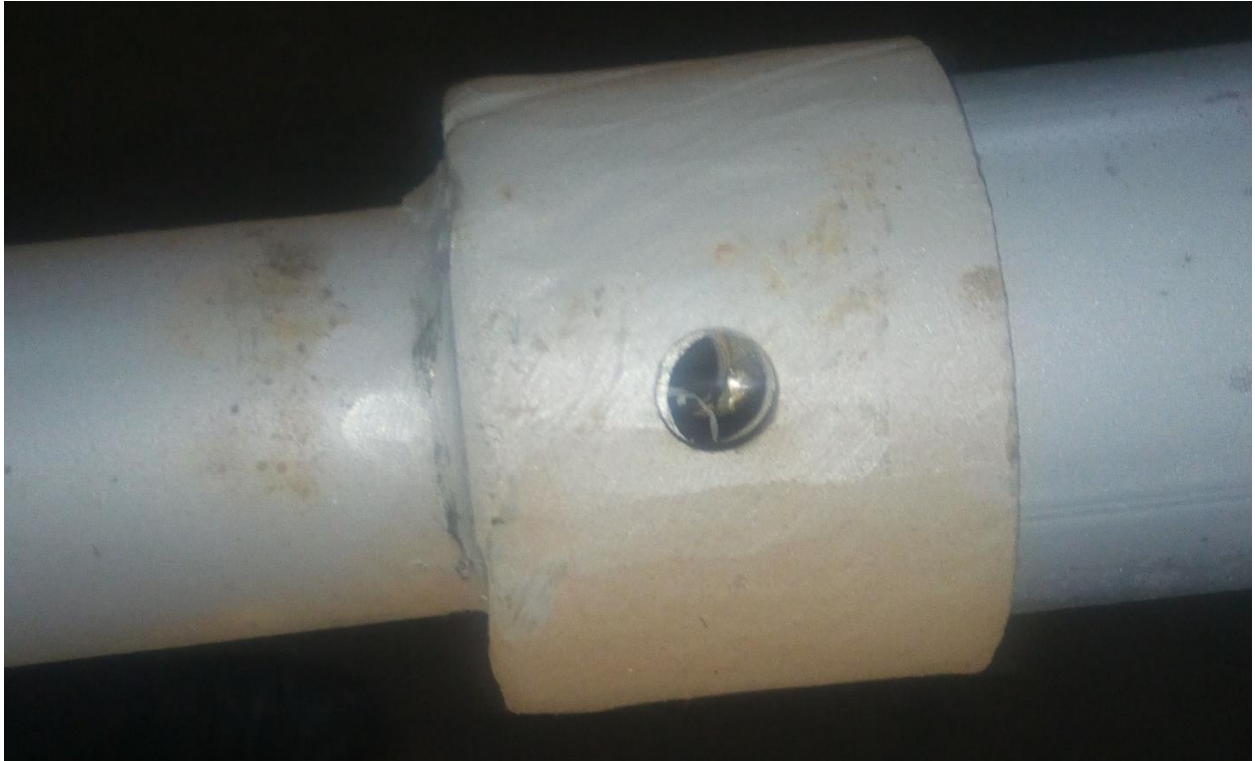
Figure 2. Joint attached to the smaller pipe, to make it fit in the bigger diameter lower pipe. The hole is for tightening the pipes during deployment

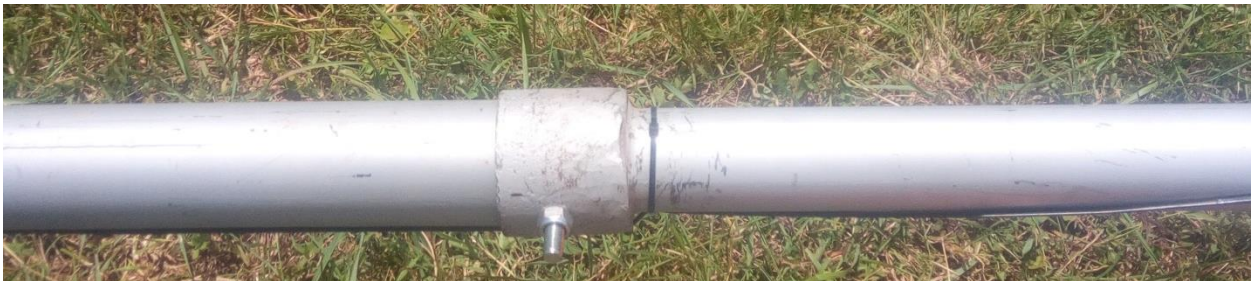
Figure 3. Two of the main pipes joined during deployment

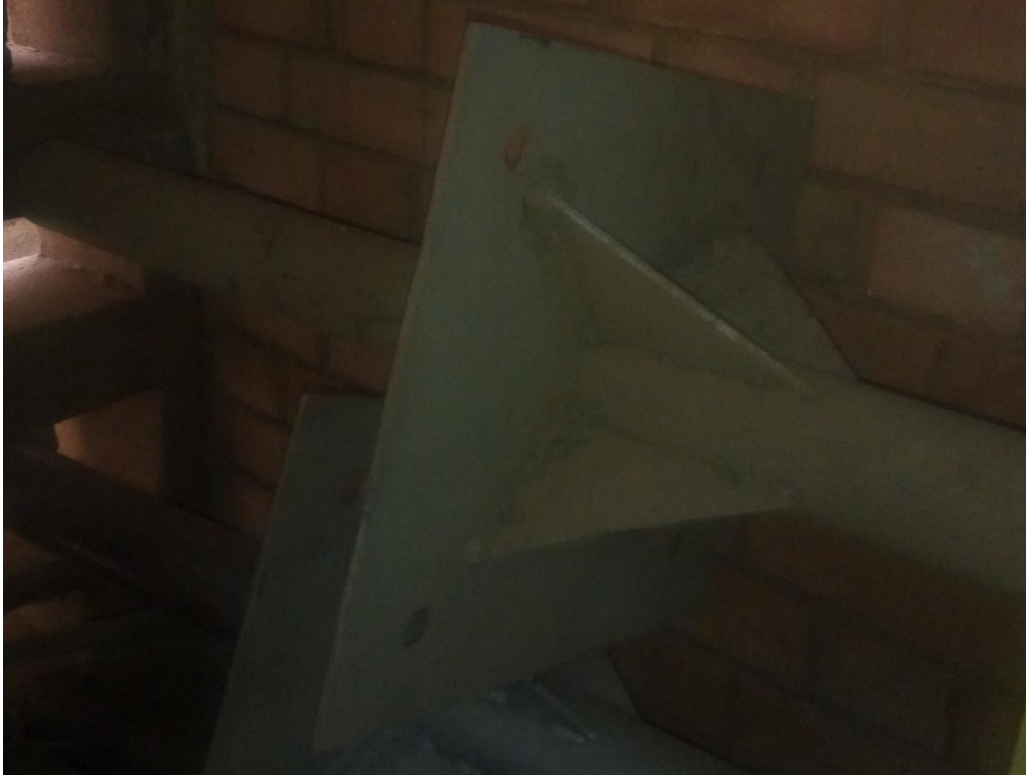
Figure 4. Metal plate that separates the area to go below and above the ground

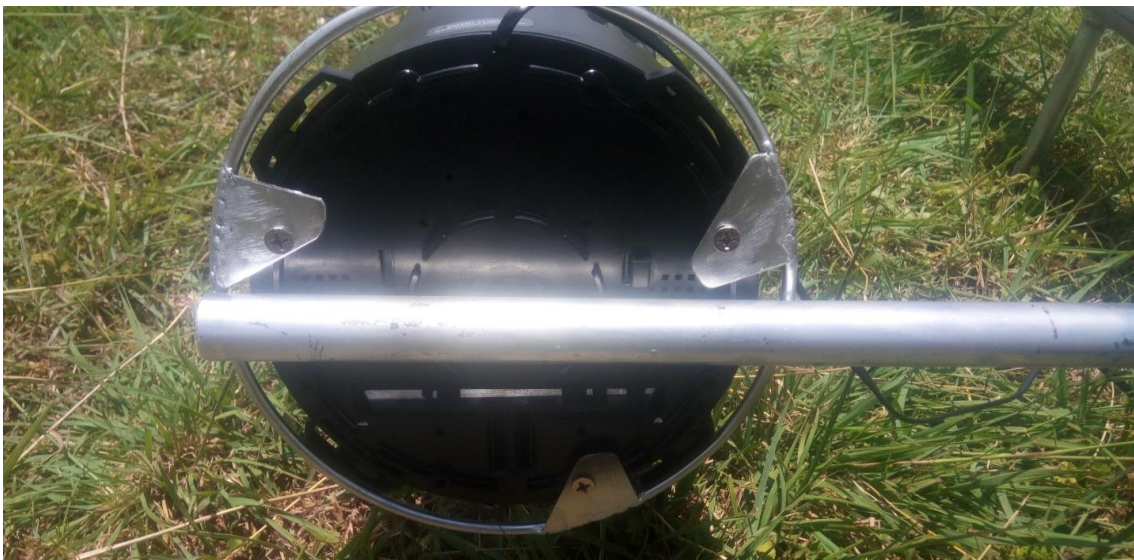
Figure 5. Rain gauge fixed to its base. The hollow pipe has a diameter of 25mm to enable it enter into another pipe, which is attached to the stand

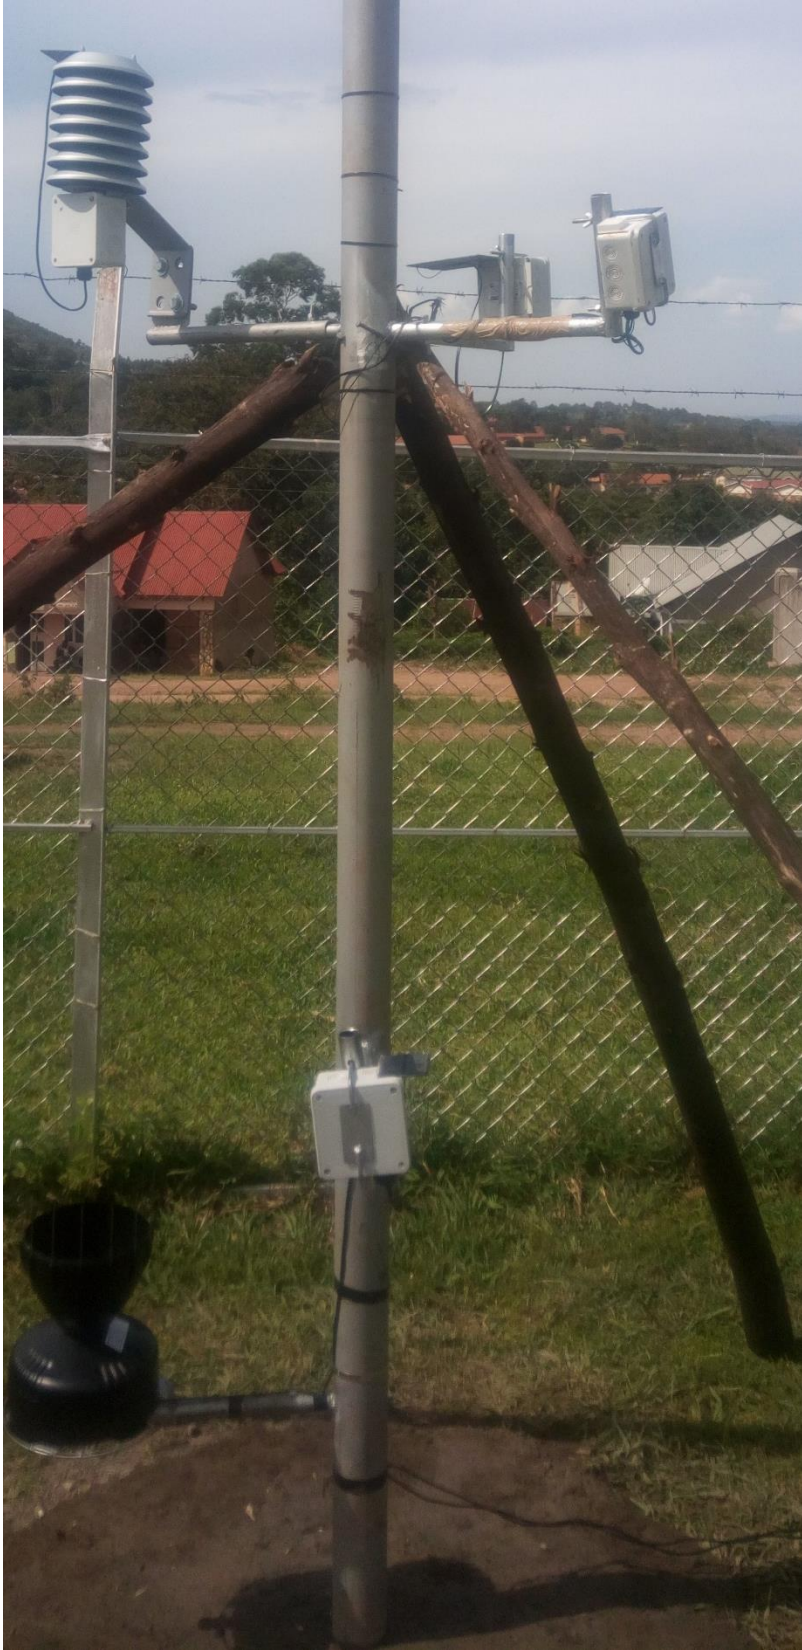
Figure 6. Sample deployed WIMEA-ICT AWS

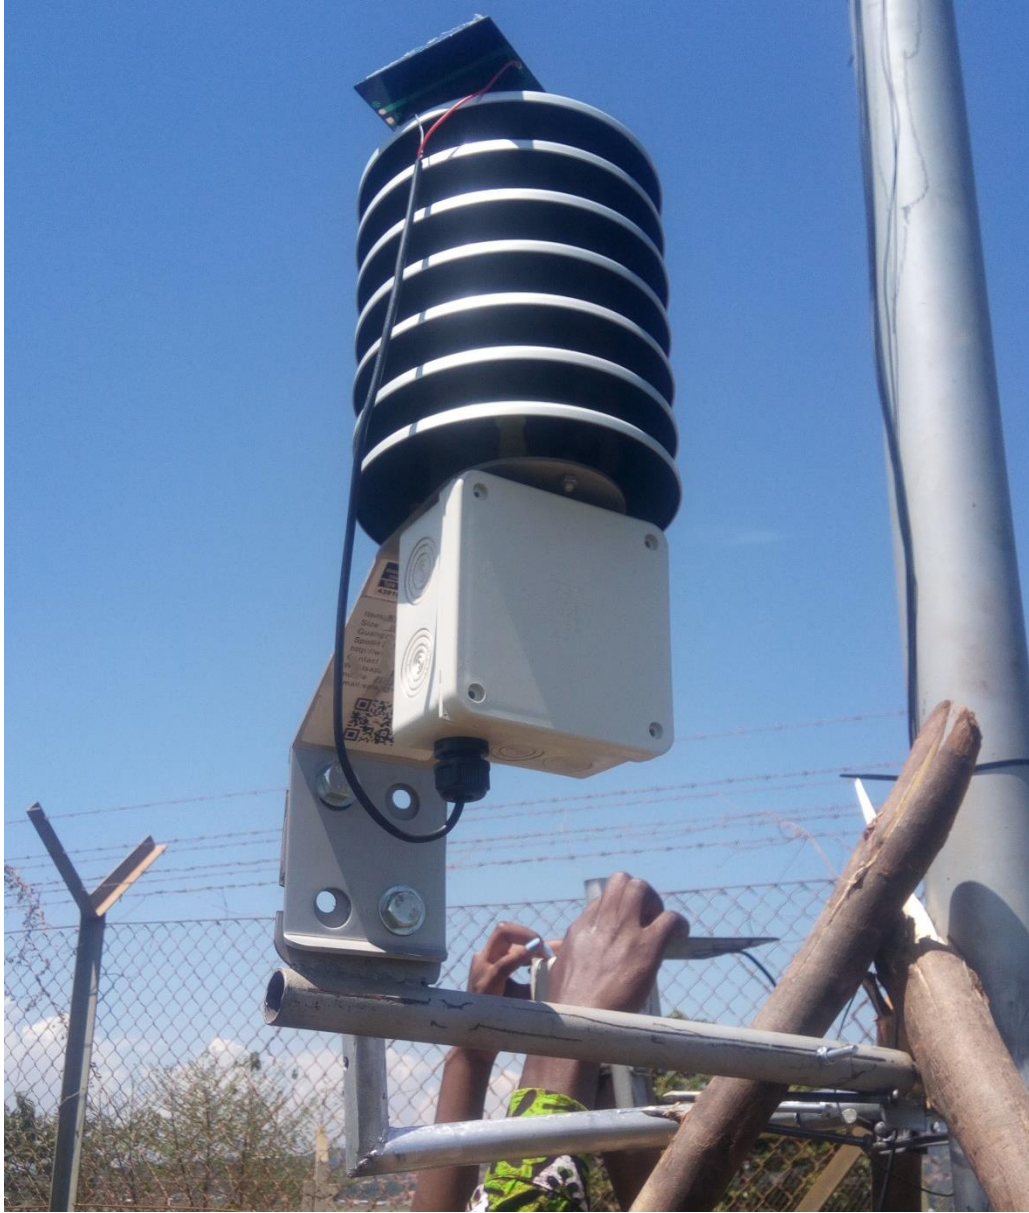
Figure 7. Protrusions for attaching sensors, approximately 2m from the ground and showing how the 2m node is attached.

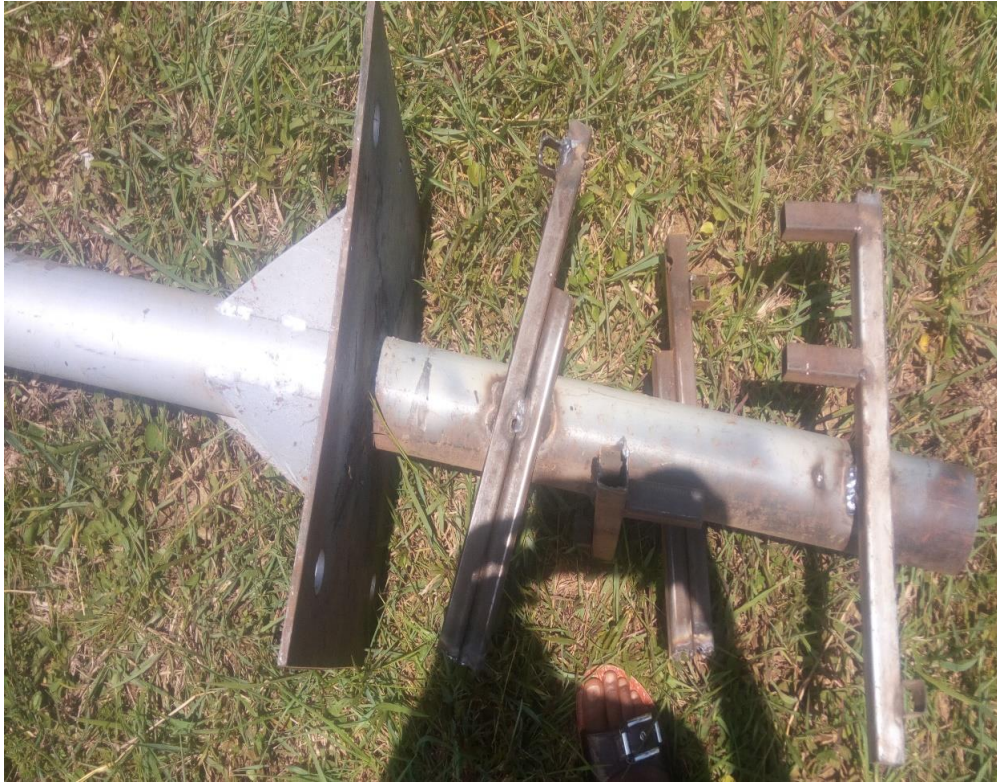
Figure 8. Lower part of the stand, which goes into the ground

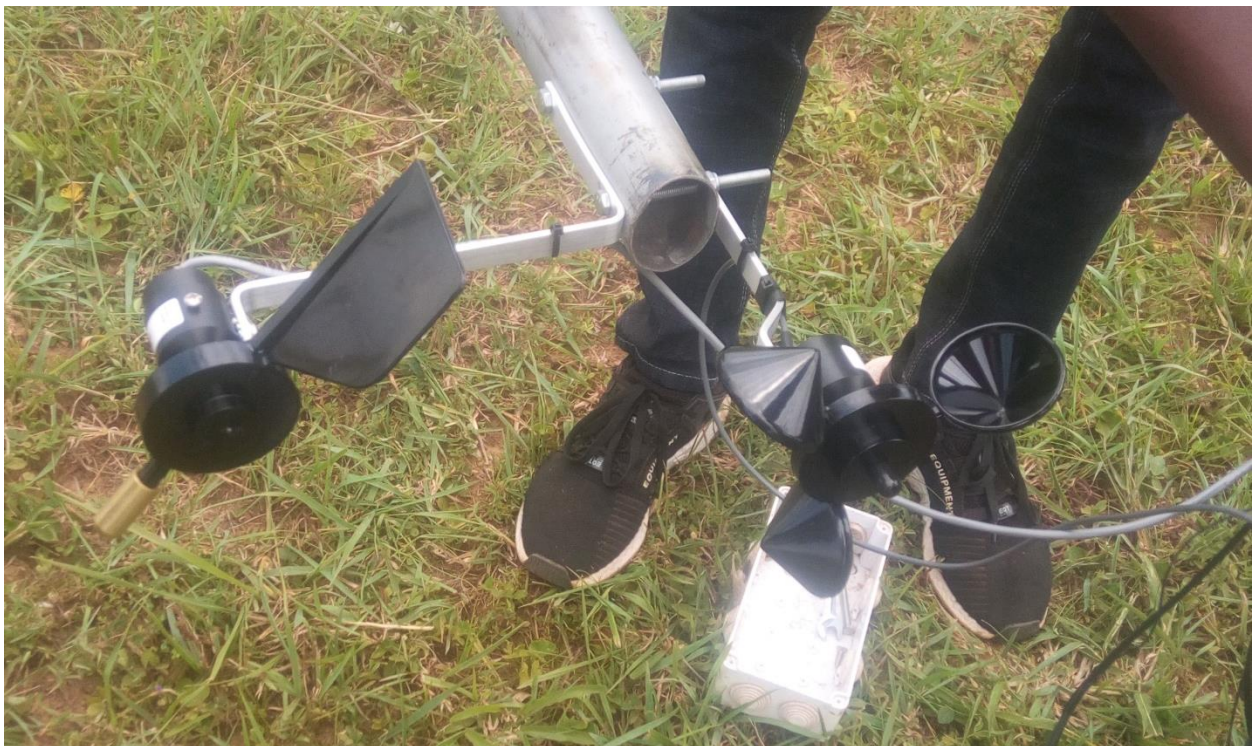
Figure 9. Attaching the wind sensors to the top metallic pipe

Transportation of the stands from Makerere University was done by a separate team. The same team also performed placement of the stands into the ground, a day or two before sensors were placed on the stands. Before erecting the stands, the wind vane and anemometer were attached and a cable left to enable the deployment team to attach the sensor node.

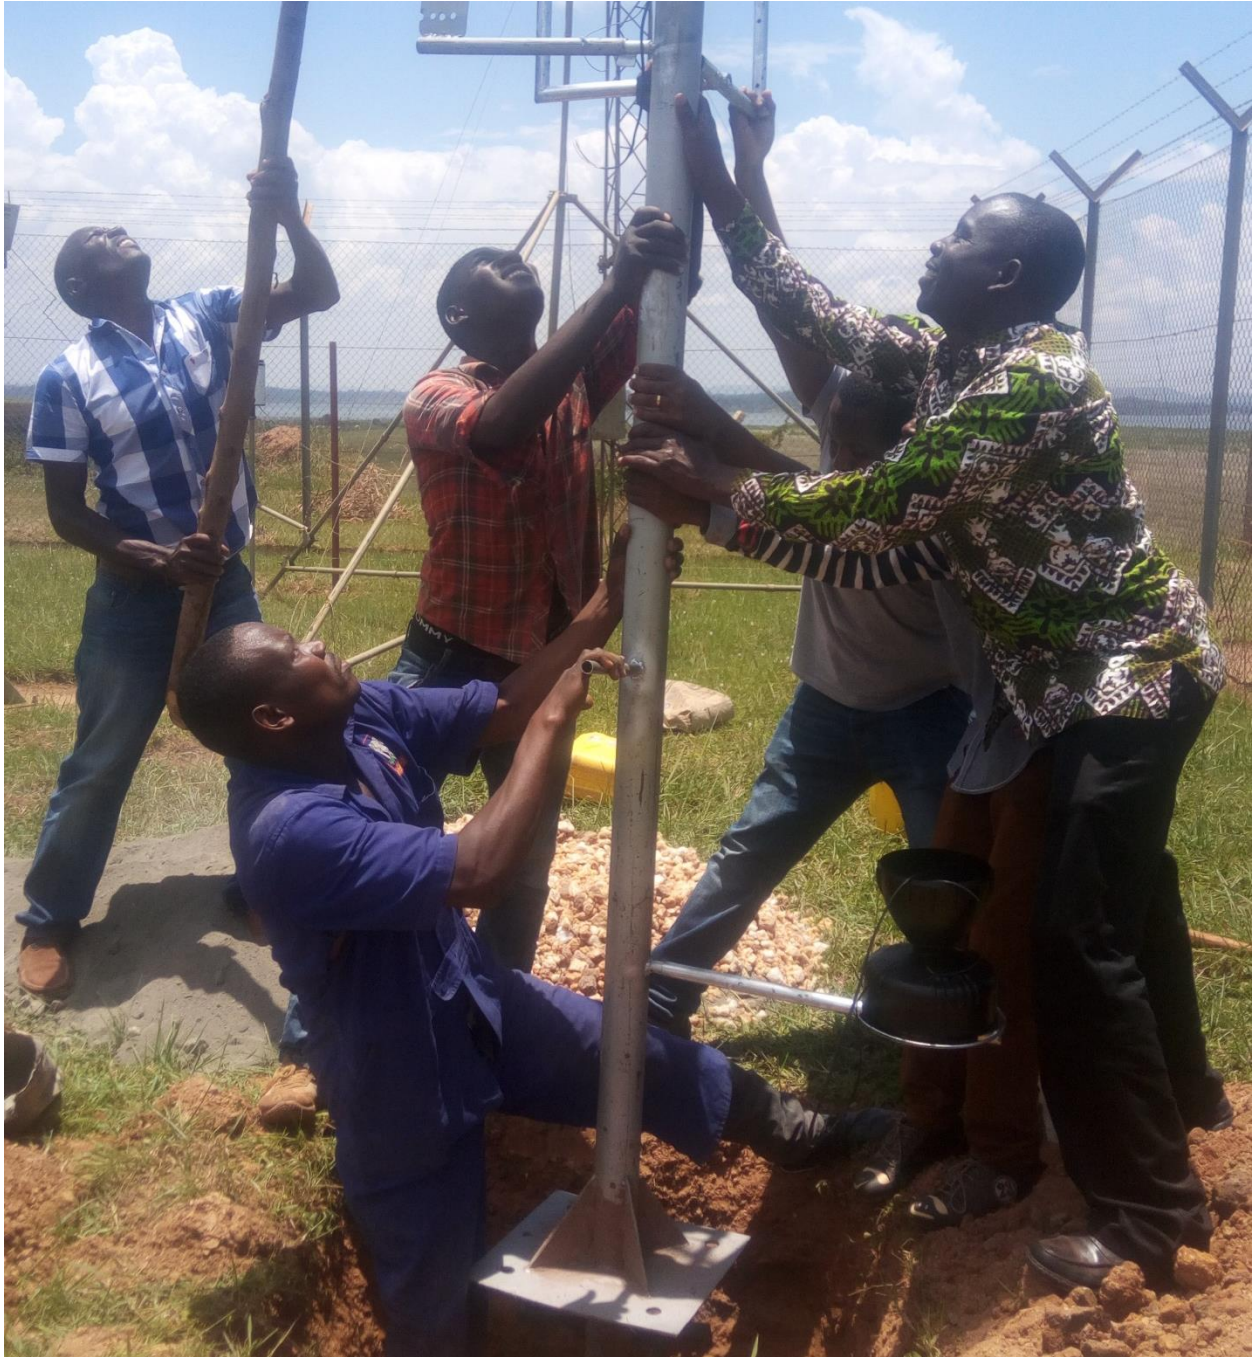
Figure 10. Laying concrete works

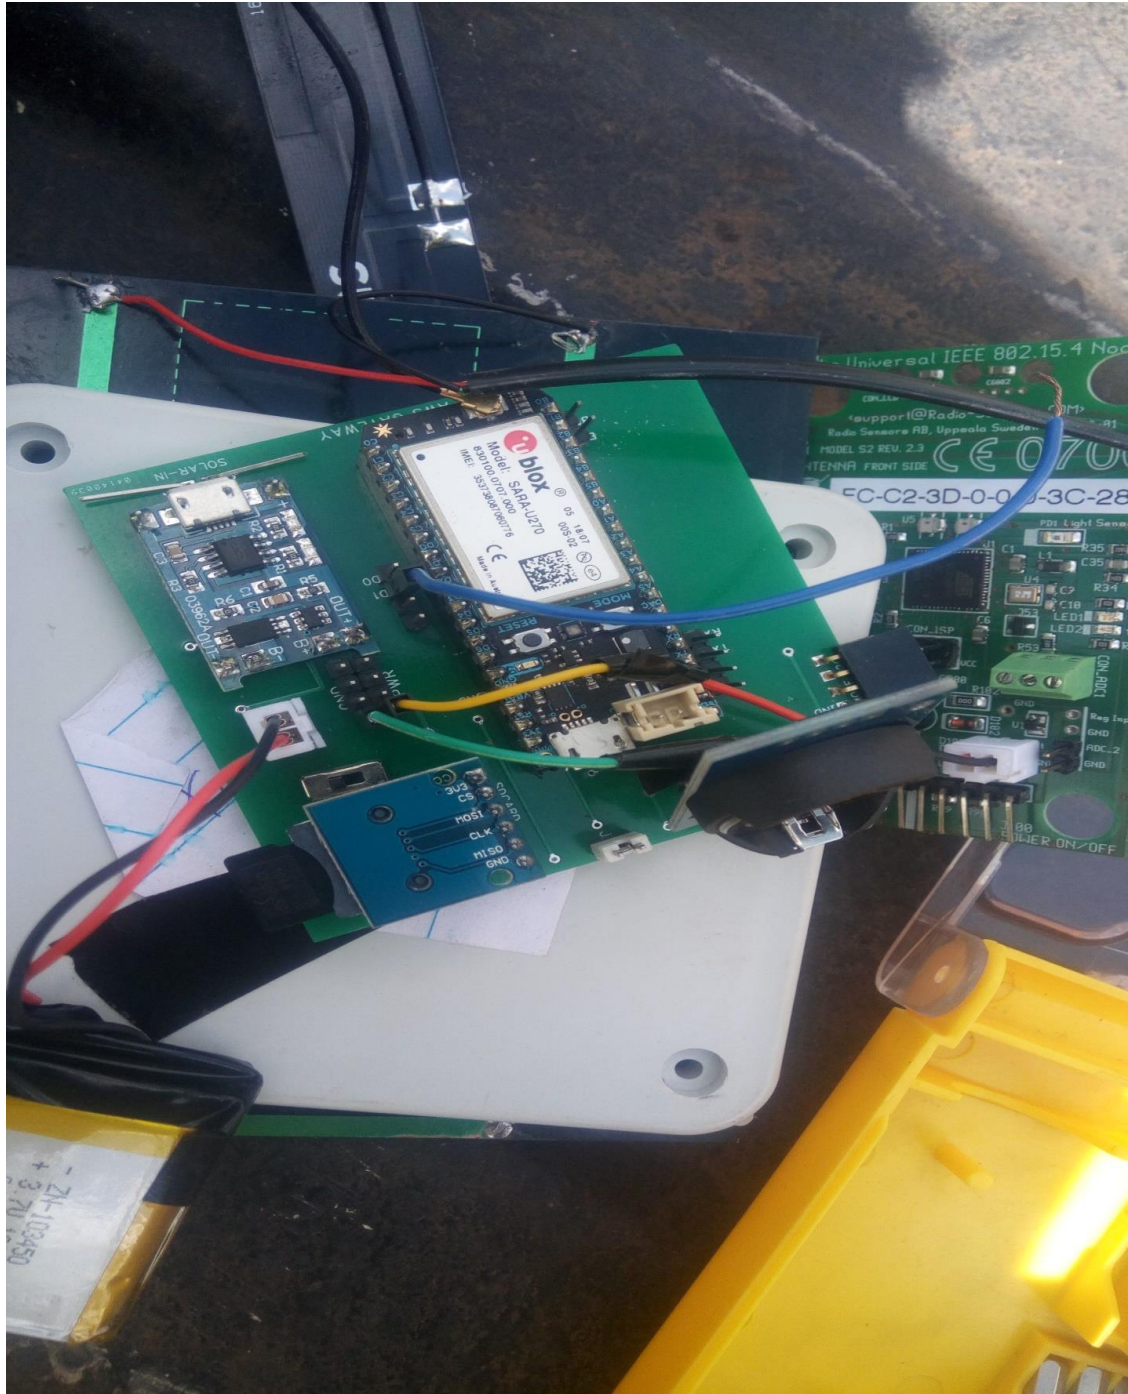
Figure 12. The Low Power Gateway used in the deployments

- vi. Assembling and onsite testing of the low power gateway. Below are the activities that were performed in regards to setting up the gateway
 - a. Ensuring that connections were correctly done, leaving no loose connections.

- b. Observing the Light Emitting Diode (LED) color to establish if the gateway was in error mode, attempting to connect, transmitting, idle or has successfully transmitted.

- c. Testing the SD card to ensure that data was successfully saved and that the configurations including the Internet Service Provider details and number of reports were properly configured

- d. Testing signal quality and network connectivity in the area using the selected telecommunication provider. MTN or Warid, telecom were proposed by UNMA for uplink connection. We used MTN SIM cards in all sites

- e. Testing the RTC date to ensure that the time and date issued were correct
